# Manhole Inspection Summary

Manhole # S09OO1021MH

Insp Date: **5/18/07 1:28 PM**

**Location** Address: **3323 GARRISON AVE**

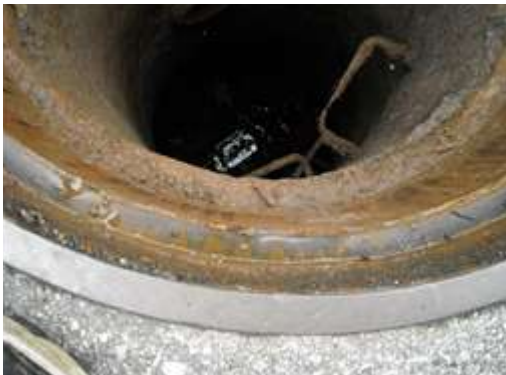
Defect 5

Offset: **1** (in.)

FRAME OFFSET

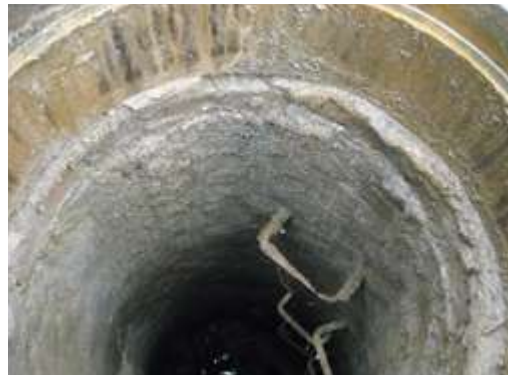
Defect 4

INFILTRATION CHIMNEY

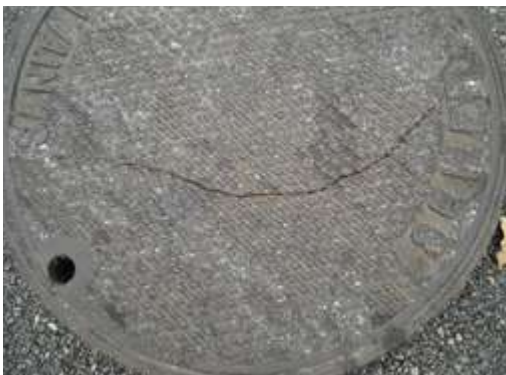
Defect 1

Condition: **Cracked**

CRACKED LID

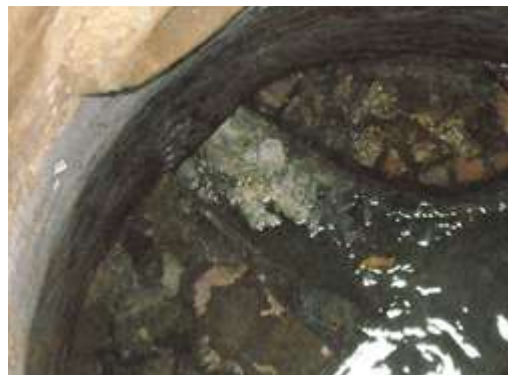
Defect 3

Condition: ☐ Sound ☐ Cracked ☐ Root Intrusion ☐ Deteriorated ☐ Leaks ☒ **Debris**

DEBRIS IN CHANNEL

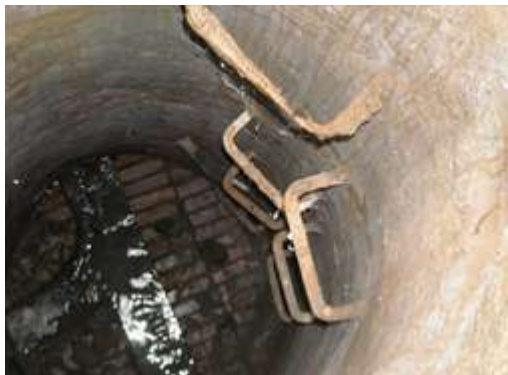
### Defect 2

Count: **7** Missing: **0** ☒ **Corroded**

CORRODED STEPS

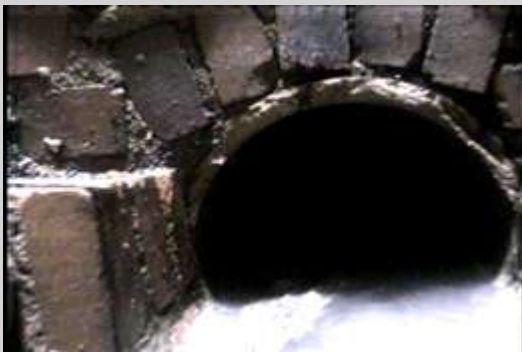
12 O'Clock Outflow

Pipe Height: **13.2** (in.) Rod and Bar (Angled)  
Pipe Material: **Clay** ☐ Pipe Lined  
Invert Depth: **14.83** (ft.) Flow Characteristics: **Slow**  
Deposits: ☒ None ☐ Mud ☐ Sludge ☐ **Debris** ☐ Grease  
Silt Depth: (in.) Deposits Extent:  
Infiltration: **None** Pipe Seal Cond: **Cracked**

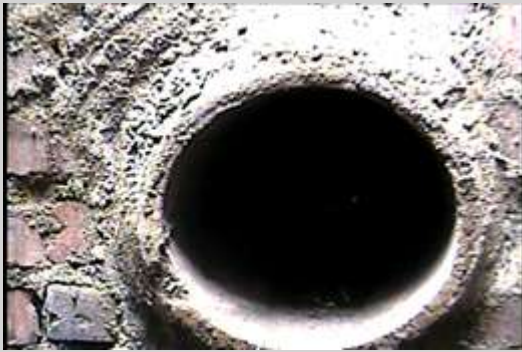
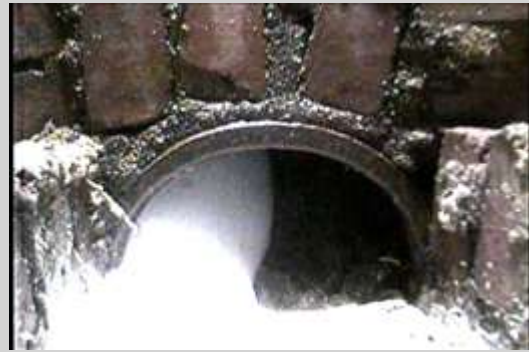
9 O'Clock Inflow

Deposits: ☐ None ☐ Mud ☐ Sludge ☒ **Debris** ☐ Grease

Silt Depth: **4** (in.) Deposits Extent: **Medium**
